Engineering Summary Report

LOG-13-1.58

McColly Covered Bridge Over the Great Miami River

June 1997

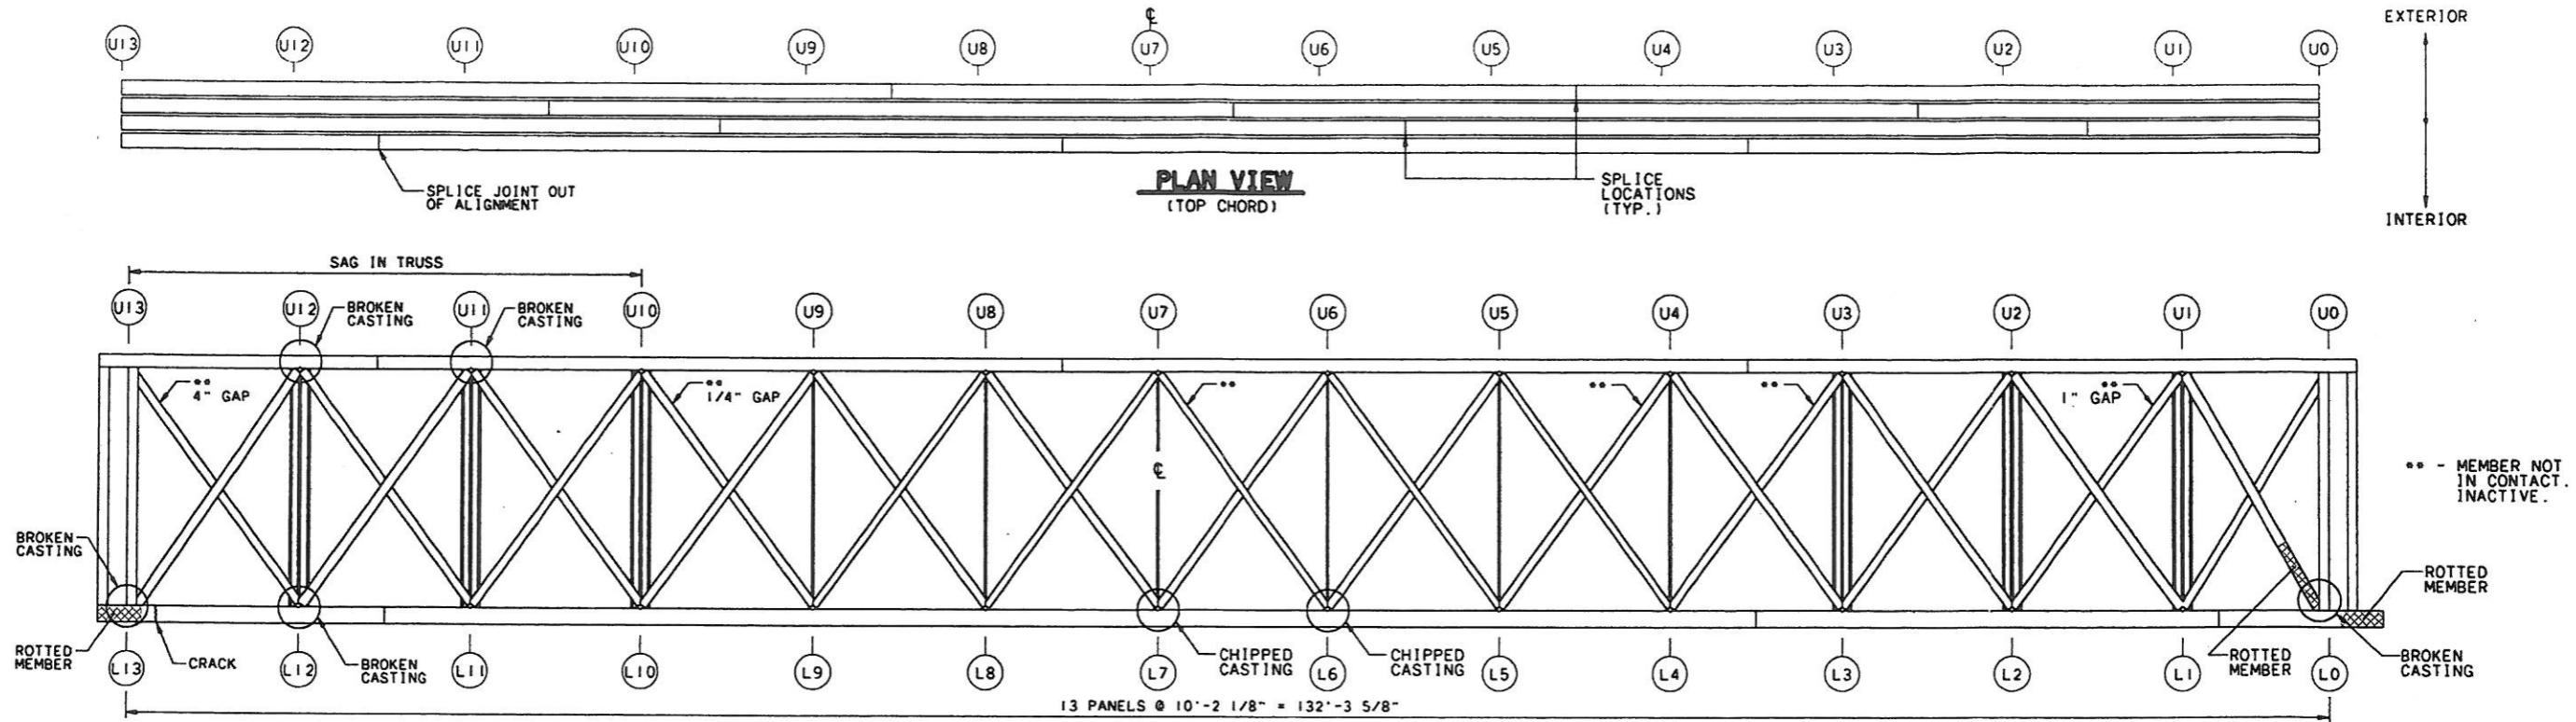
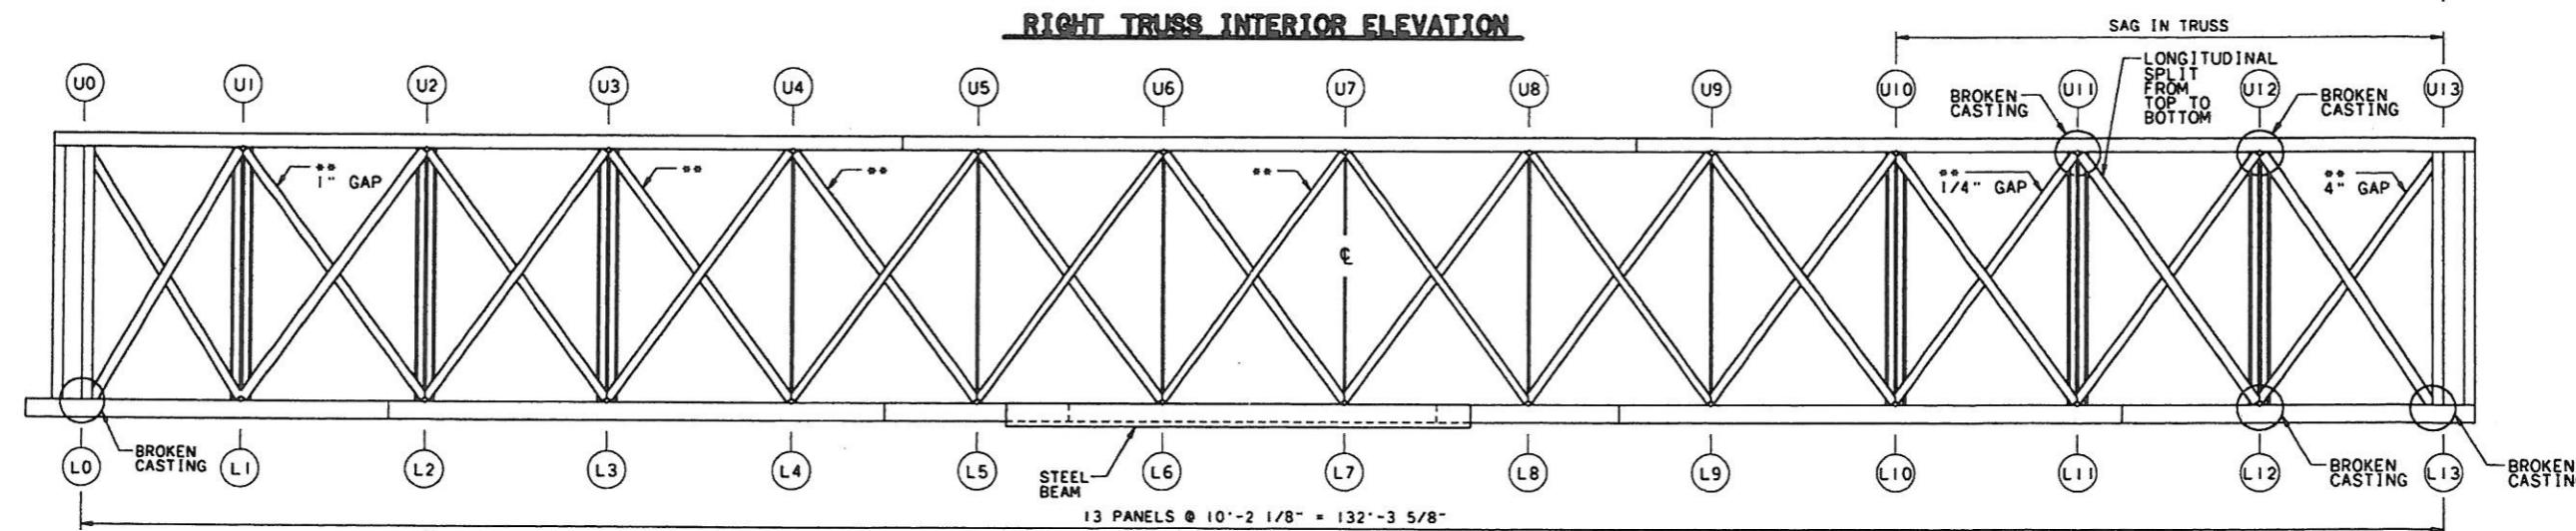
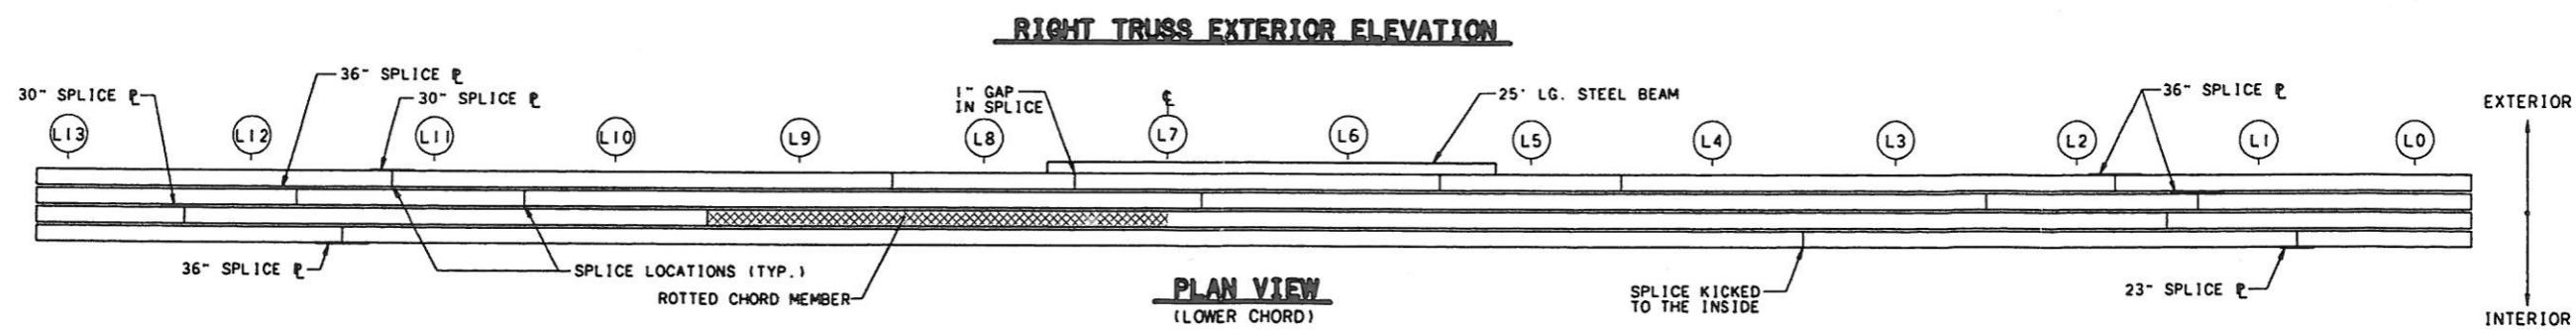
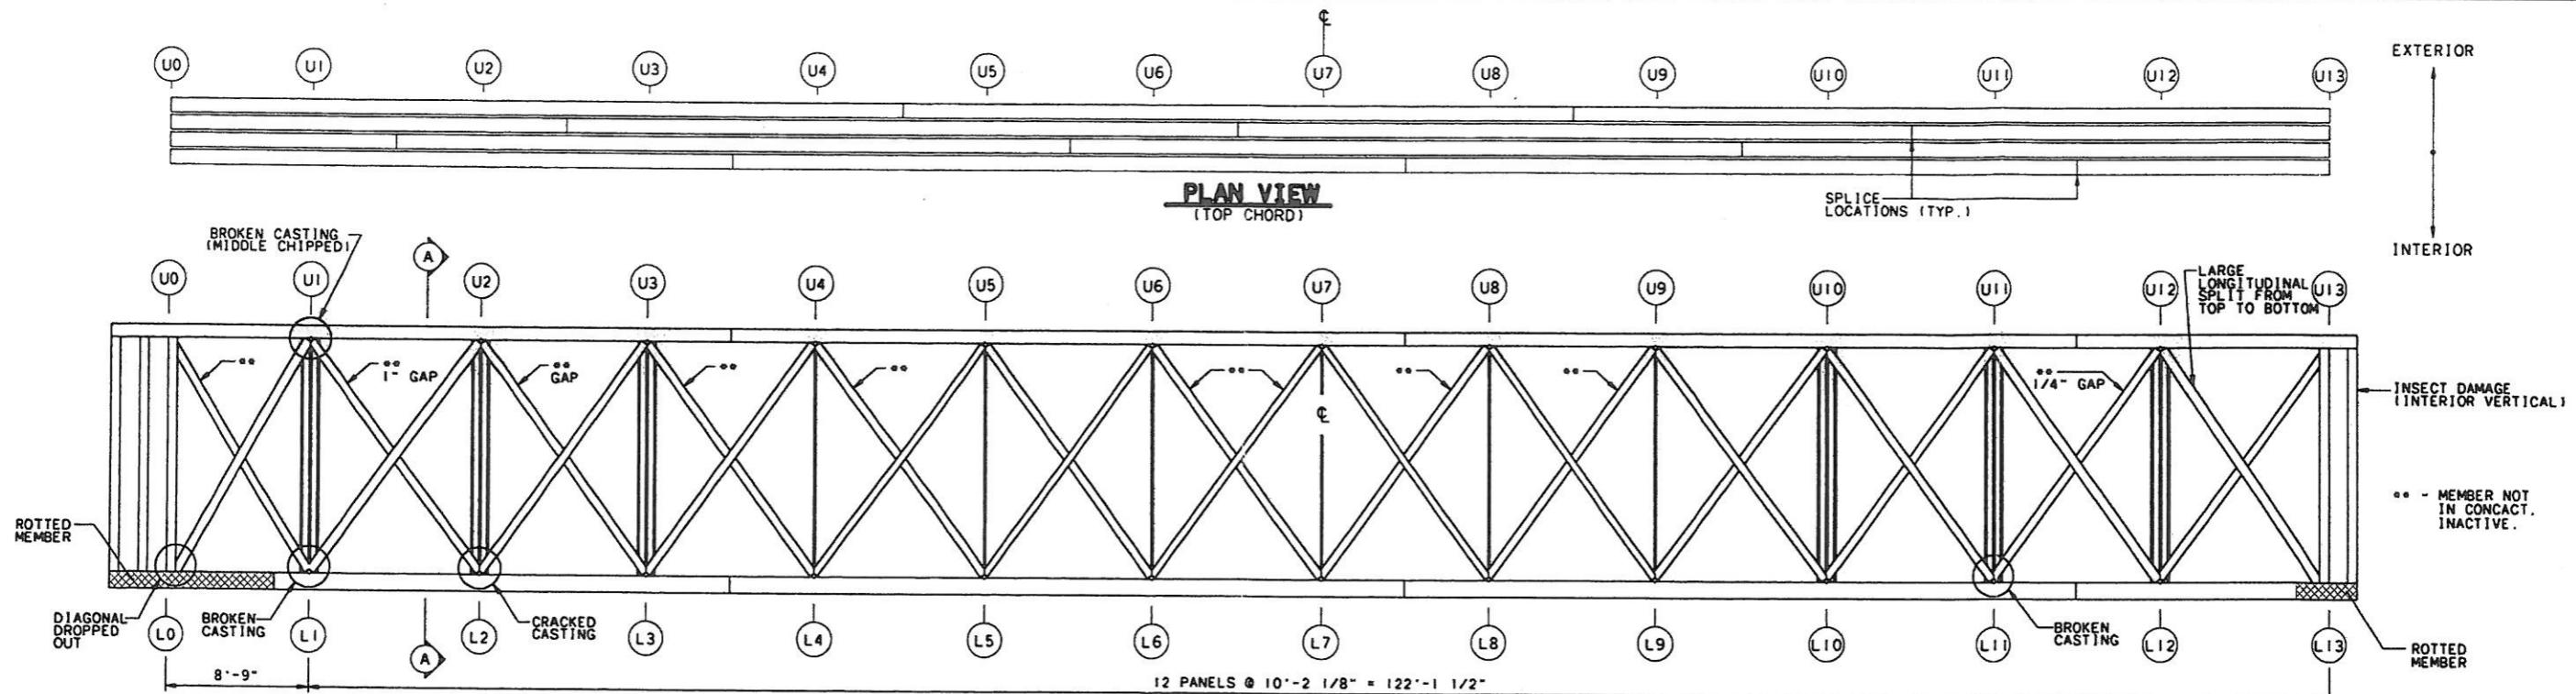
FIGURE I

Reference Figures 1 and 2 for location of superstructure conditions identified in the following narrative.

Timber diagonal braces and counter braces are framed squarely into cast-iron angle blocks that are framed into the upper and lower chord members. Generally the diagonals are in fair condition; however, several exhibit rot at the lower ends. Those diagonals that exhibit rot are in locations where the siding has been removed allowing water to collect on the members. Approximately 60 percent of the counter braces are loose or are completely removed from the angle block. Approximately 20 percent of the cast-iron angle blocks are cracked or completely broken.

The lower chord also consists of four timber members continuous from abutment to abutment. The lower chord is in critical condition. Rot is evident at several locations along the chord. At the abutments, the rot has resulted in significant loss of section. At the individual member joints the rot has allowed the joints to open which has increased the stress in the remaining members resulting in member fractures and sagging of the superstructure. Fractures of the chord members at the abutments were noted. Steel beams have been added to the lower chords to keep them together.

- Clean and paint existing floor system.
- Replace timber decking.
- Replace broken or deteriorated siding boards. Boards in good condition would be reused.
- Replace deteriorated, rotted, or insect infested members located in Figures 1 and 2.
- Supplement vertical rods 56 and 65 with compression members.
- Install tension rods on each side of lower chords.
- Restore original configuration of end post and first panel of left truss.
- Provide tension connection for end posts.
- Add pier supports.
- Repaint structure.
- Cover members with fire retardant.
- Replace bearings.
- Remove shingles and replace metal roof with new metal roof.
