Engineering Summary Report

LOG-13-1.58

McColly Covered Bridge Over the Great Miami River

June 1997

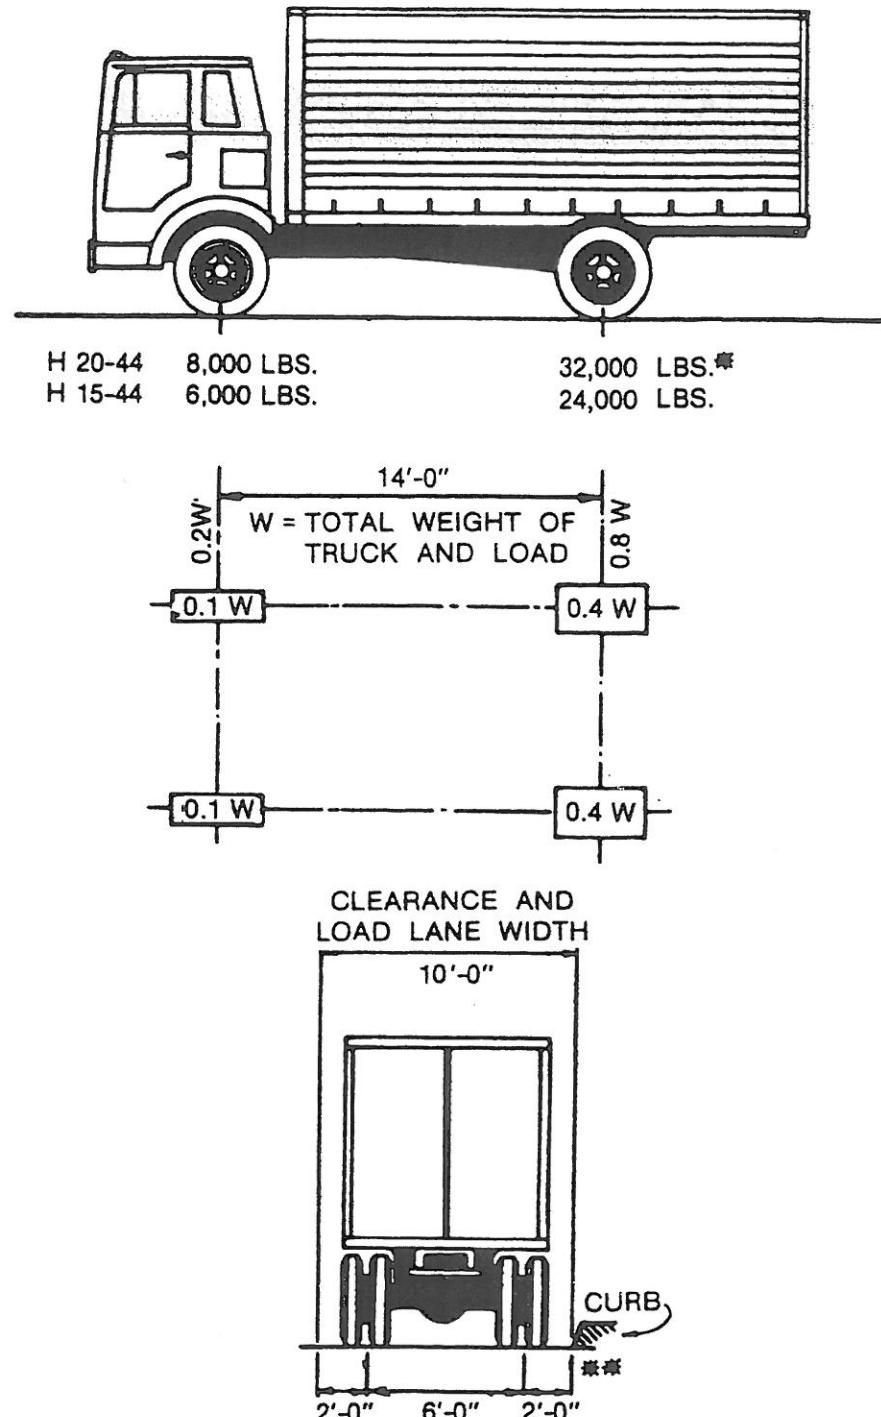
FIGURE 3

Primary live load analysis is based on American Association of State Highway and Transportation Officials (AASHTO) H15 loading. This represents a single 15 ton truck with two axles spaced at 14 feet (Figure 3). Half of the live load is applied to each truss. The live load was applied to the truss as a moving load from one end to the other to determine the maximum and minimum loads within each member.

Burgess & Niple recommends the above repairs be performed if the rehabilitated bridge is to carry the H15 loading (Figure 3) or the lesser weighing school bus loading (Figure 4). Without the addition of piers, the maximum load which could be supported by the rehabilitated bridge is only 8 tons.

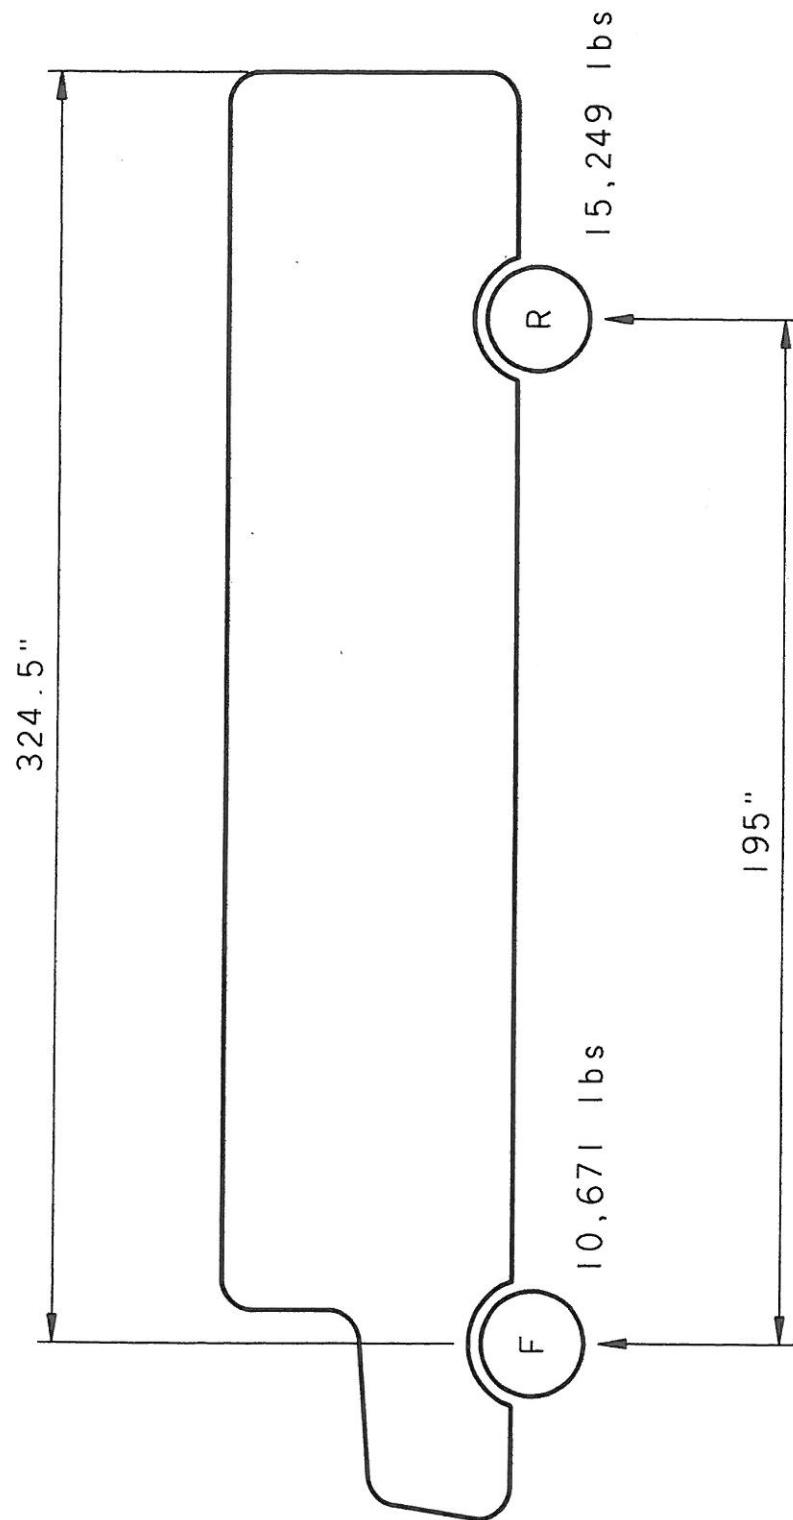
FIGURE 4

A secondary live load representing a school bus fully loaded with children was also applied to the truss. The bus live load shown in Figure 4 was applied in the same manner as the H15 truck load.

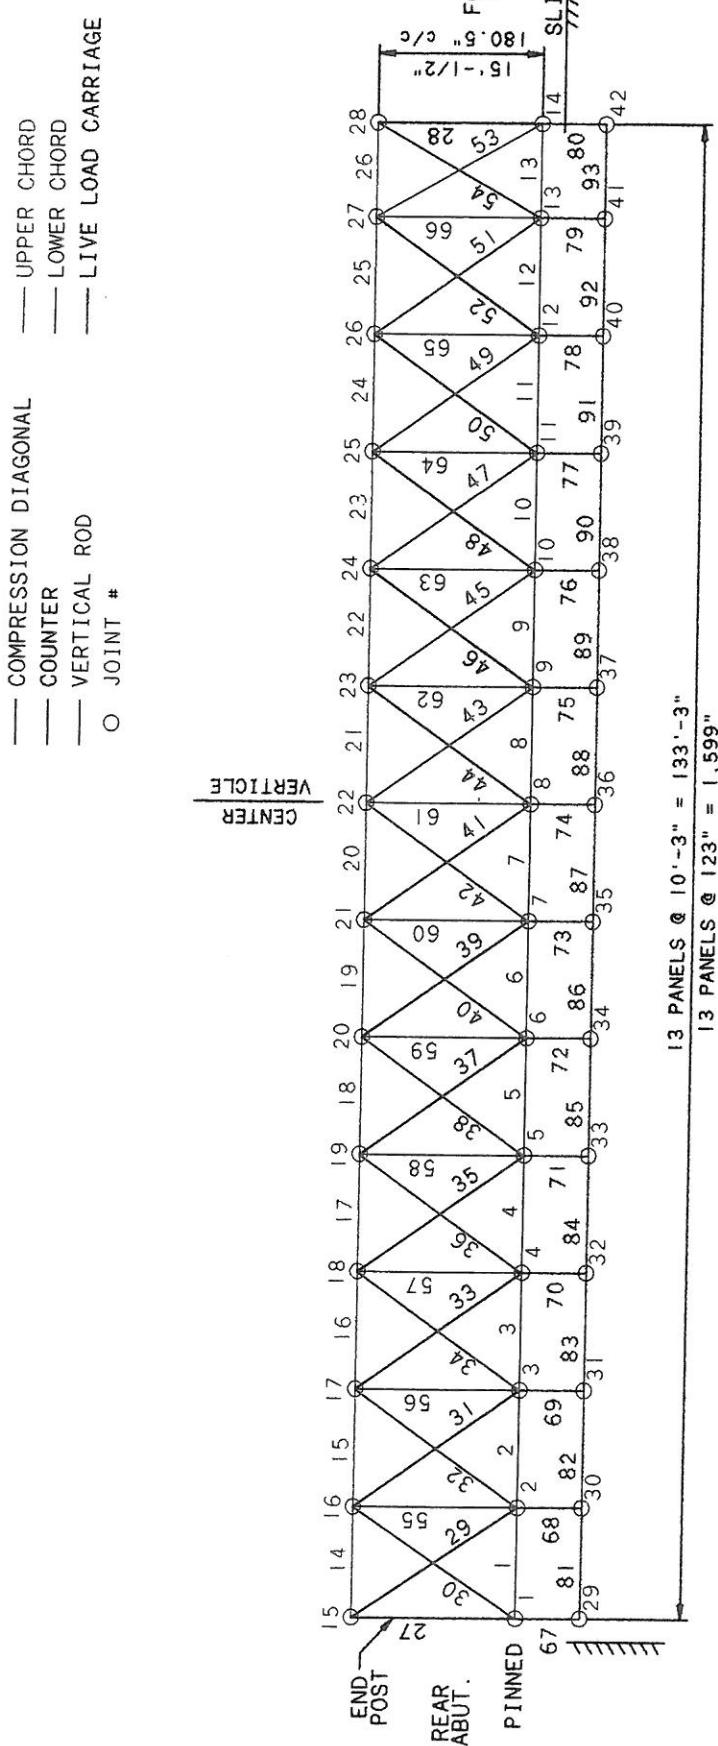
FIGURE 5

A plane frame analysis was performed on the trusses using STAAD III release 21, developed by Research Engineers. The model created within STAAD is shown in Figure 5. Members 27 through 66 are designated as truss members, which by definition are capable of axial loads only. Members 67 through 93 are added to the truss to model the actual transfer of live loads to truss panels through the floorbeams.

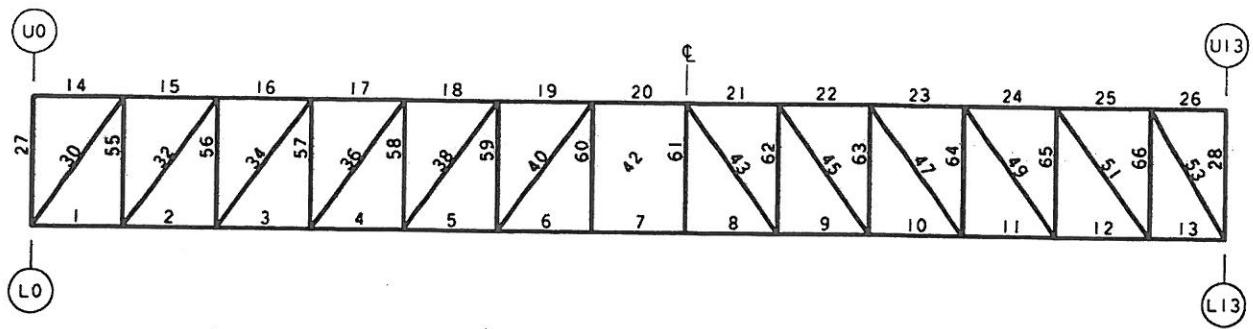
FIGURE 6: 0.0H15 → 0.60H15
EVENT A

The initial truss configuration for live load analysis is shown in Figure 6. This configuration, without counters and member 42, is valid up to 60 percent of H15 live load. This load level, defined as EVENT A, establishes the level at which members 40 and 43 are in tension and become inactive.

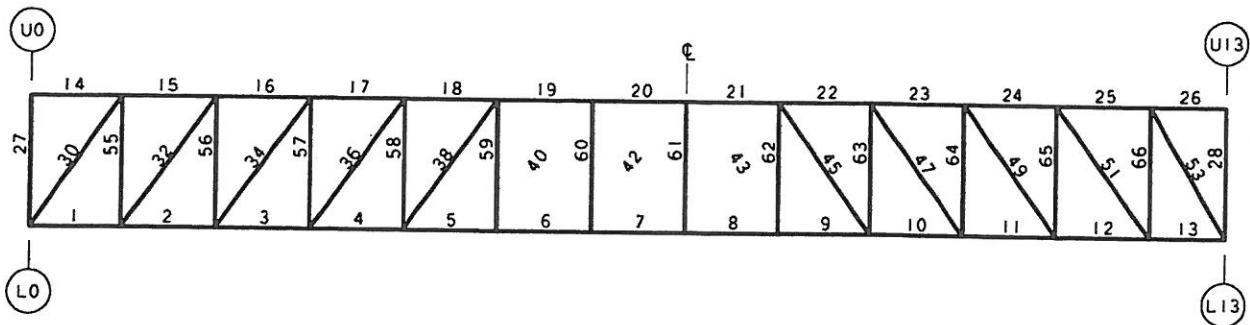
FIGURE 7: .060H15 → 0.92H15
EVENT A → EVENT B

Figure 7 shows the truss configuration for live load analysis between EVENT A and EVENT B (0.92 H15). Beyond EVENT B, members 38 and 45 become inactive (Figure 8). This configuration is valid to EVENT C. EVENT C represents 100 percent of H15 live load.
